# REPORT 1009

## INVESTIGATION OF FRETTING BY MICROSCOPIC OBSERVATION<sup>1</sup>

By DOUGLAS GODFREY

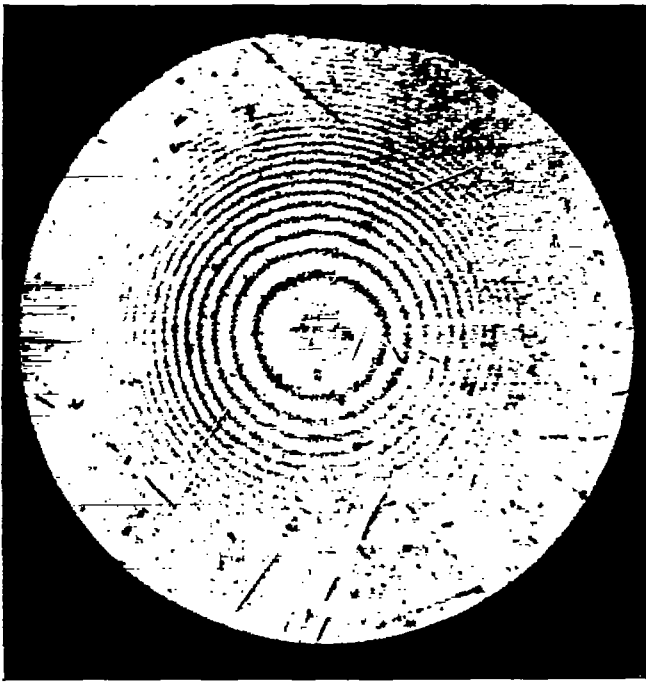
FIGURE 2.—Photomicrograph with vertical illumination and red filter of chrome-alloy steel ball through glass slide showing interference bands surrounding contact area.  $\times 100$ .

The apparatus could be attached to the mechanical stage of a microscope, which permitted microscopic observation of the contact area with vertical or oblique illumination. With transparent flat specimens, the contact area could readily be located because it was surrounded by concentric interference bands (fig. 2). Amplitude was measured by noting the distance between the extreme positions of a scratch mark on the vibrating surface. The experiments conducted at 120 cycles per second were divided into three groups: (1) the preliminary metal against metal, (2) the metal against nonmetal, and (3) the nonmetal against nonmetal. No general material survey was made and the number of metals used was limited.

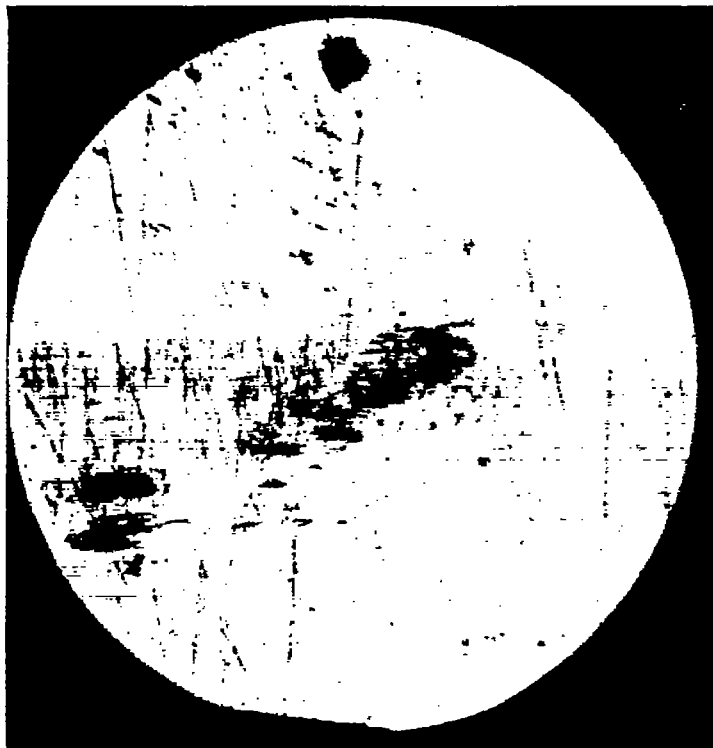
(a) Early stage.

(b) Advanced stage.

FIGURE 6.—Photomicrographs of convex platinum surface through glass slide showing wear and debris produced.  $\times 120$ .

(c) Debris accumulation outside field of view of figure 6 (b).

Results obtained when other metals were vibrated against glass slides supported the explanation of fretting deduced from the steel-glass experiments. In one experiment, flame-cleaned platinum foil supported by a steel ball was vibrated in contact with clean glass. The generation of a black powder in the characteristic way was observed (fig. 6). This powder remained black and that which adhered to the glass could be completely removed only by a 4-hour treatment in aqua regia. Color, acid resistance, electron-diffraction patterns, and source indicated that the material was finely divided platinum (platinum black). Because platinum will not oxidize in air at any temperature, the theory that oxidation is a primary cause of fretting is not supported.
